FRESHWATER ASSESSMENT FOR THE WORKS UNDERTAKEN ON FARM 1314 AND 1315 NEAR STELLENBOSCH IN THE WESTERN CAPE

JULY 2019

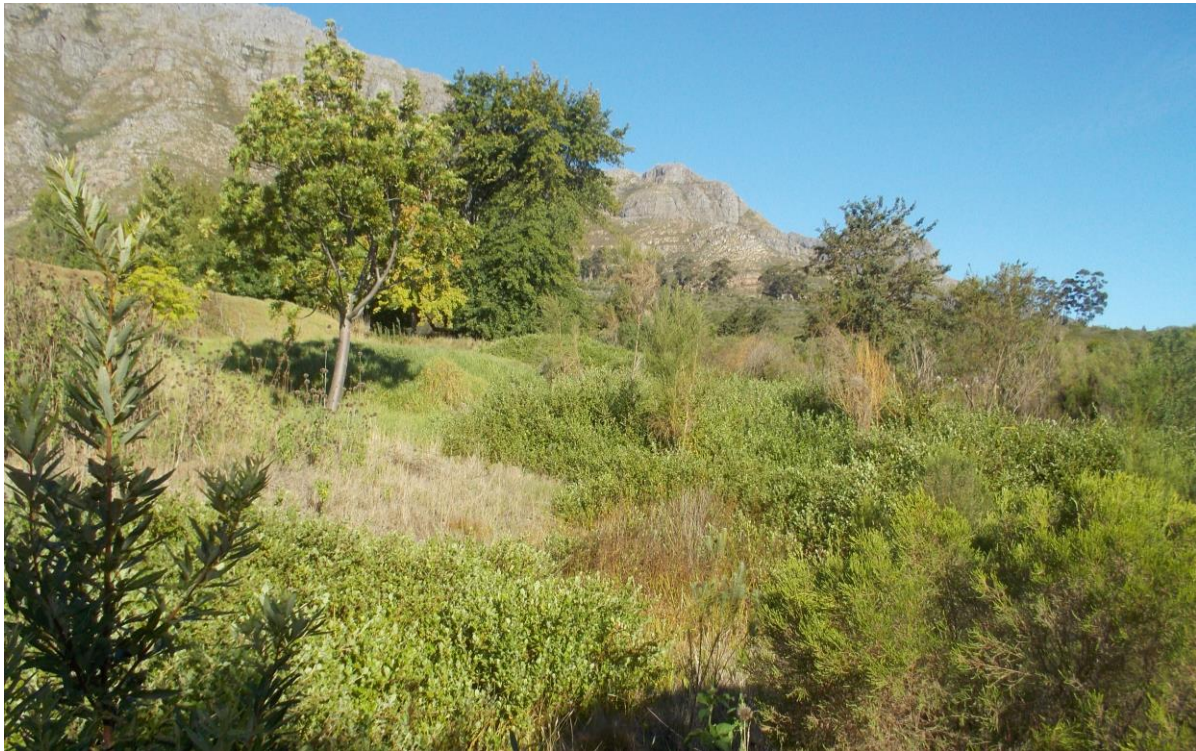
Figure 3. Photograph taken from the Paradyskloof River where it enters Farm 1314

The site is located south-east of the town of Stellenbosch within the surrounding agricultural areas. The area has an undulating topography associated with the western slopes of the lower foothills of the Hottentots Holland Mountains. The low hills are orientated east-west, interspersed by the Blaauwklippen and Bonte Rivers. The landscape is dominated by cultivated lands, with little remaining indigenous vegetation. The site itself is located at the upper limit of the cultivated land, where the gradient is still relatively steep and slopes down towards the Blaauwklippen Valley and the Eerste River in the west. The elevation at the site is between 207 m and 261m above mean sea level. This upper reach of the Paradyskloof Tributary within the site drops about 55 m over a distance of 300 m, with an average slope of approximately 18%.

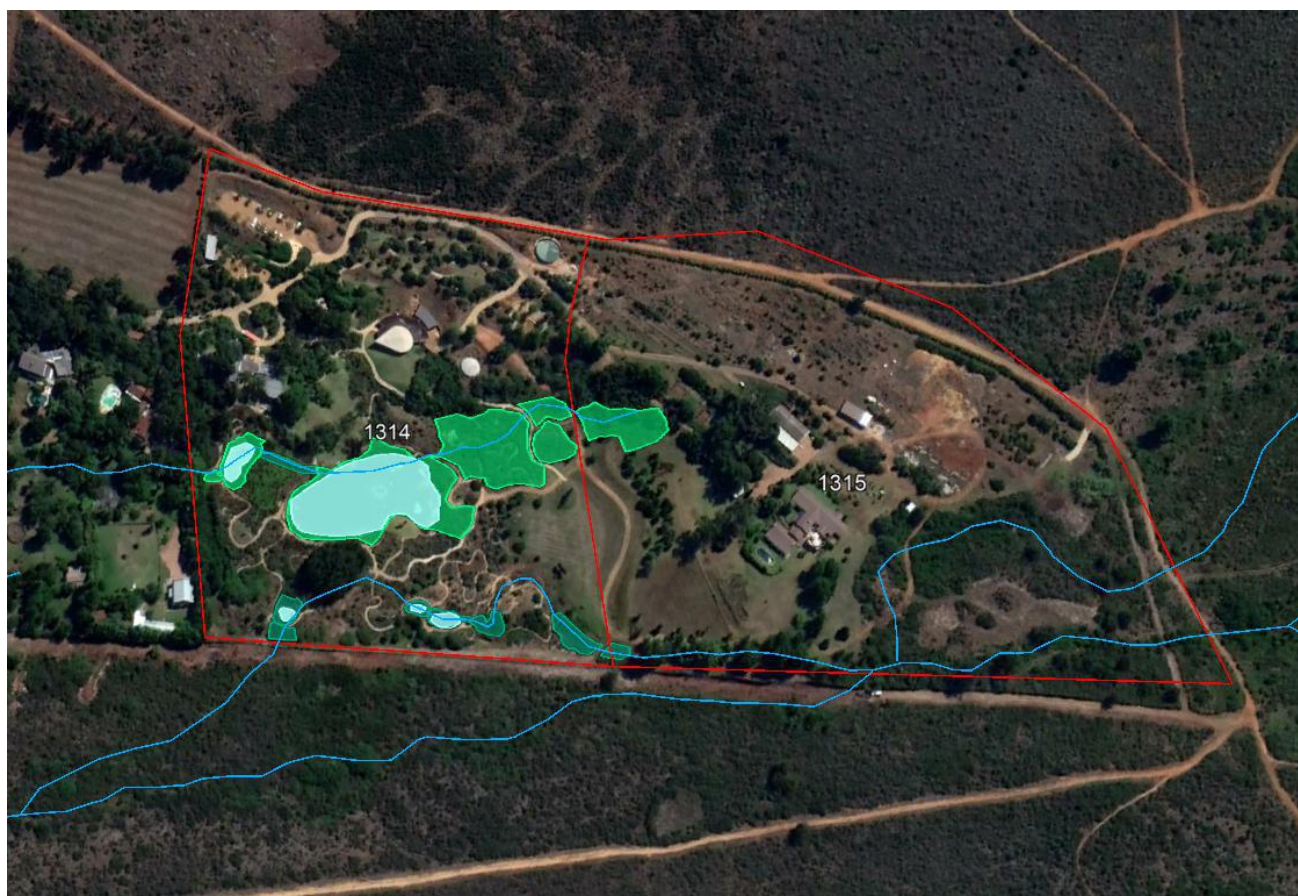
The freshwater features relevant to the proposed activity and which are assessed in this report comprise of the upper Paradyskloof Tributary and its smaller tributaries as well as the wetland habitat associated with the watercourses within the site. These freshwater features are assessed within this section.

Figure 12. Google Earth image with the mapped aquatic features at the site where the blue lines indicate watercourses, the green polygons wetland areas and the pale blue polygon the large dam. The focus area of the study is within Farm 1314 and thus the wetland areas have only been mapped in detail within this property.

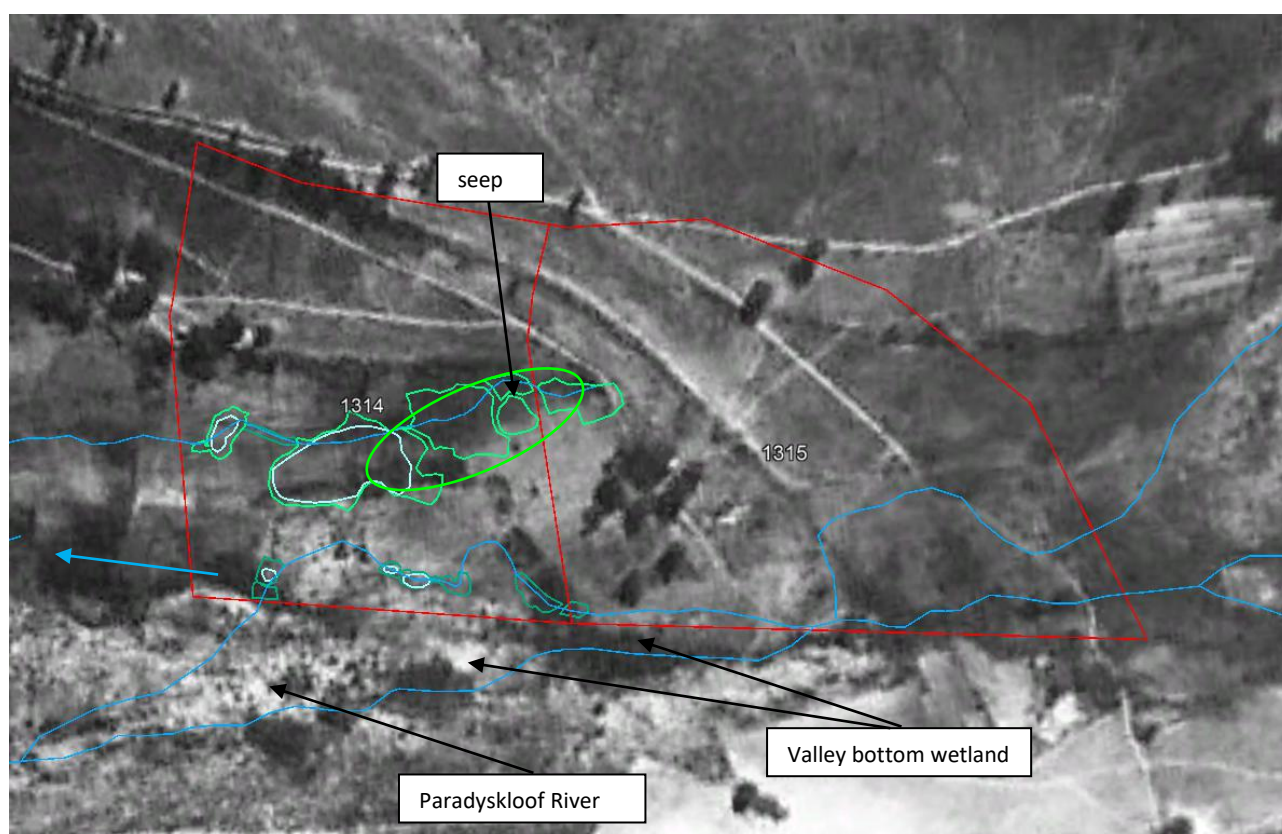
From the image it can be seen that there was a large seep wetland area (darker area in the image) at the start of the stream where the dam has been constructed that likely feeds the smaller tributary of the stream. There was also patches of valley bottom wetlands along the stream that natural appeared to flow along the southern border of the site. It would appear that at some stage the larger Paradyskloof River flowed in a north-westerly direction to join the smaller tributary in the north (indicated by the blue arrow in Figure 13), although the main channel appears to have been quite braided at that time.

Figure 13: An aerial photograph taken of the study area in 1938 with the present day delineated aquatic features shown

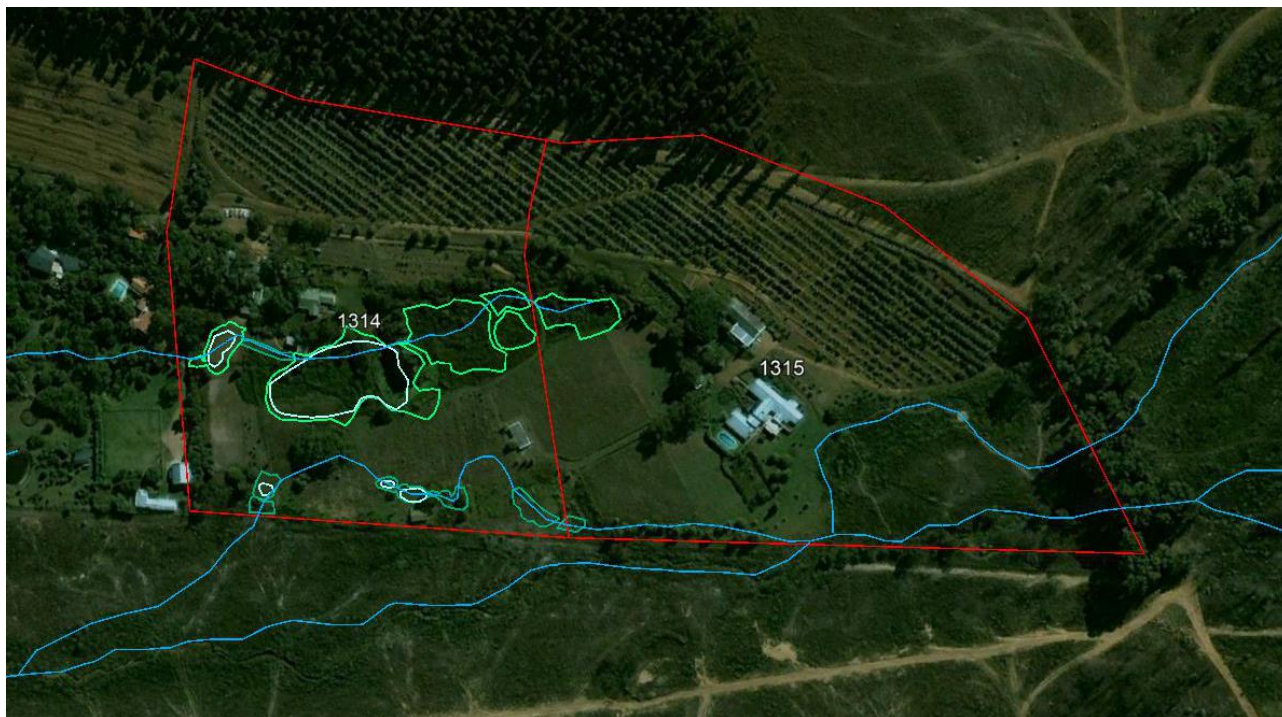
The earliest Google Earth image from March 2005 (Figure 14) shows land use within the site to still largely comprise of farming activities. A smaller instream dam occurs within a larger seep area with a straightened and modified channel carrying any overflow from the dam downstream. Access to the southern portion of

the properties appear to have been from a road along the border between the two properties as well as within Farm 1315. The Paradyskloof River split into two channels within Farm 1314, much as it is today. The three smaller ponded areas were not in place at that time.

Figure 14. Google Earth image of the site with the present day delineated aquatic features, taken in March 2005

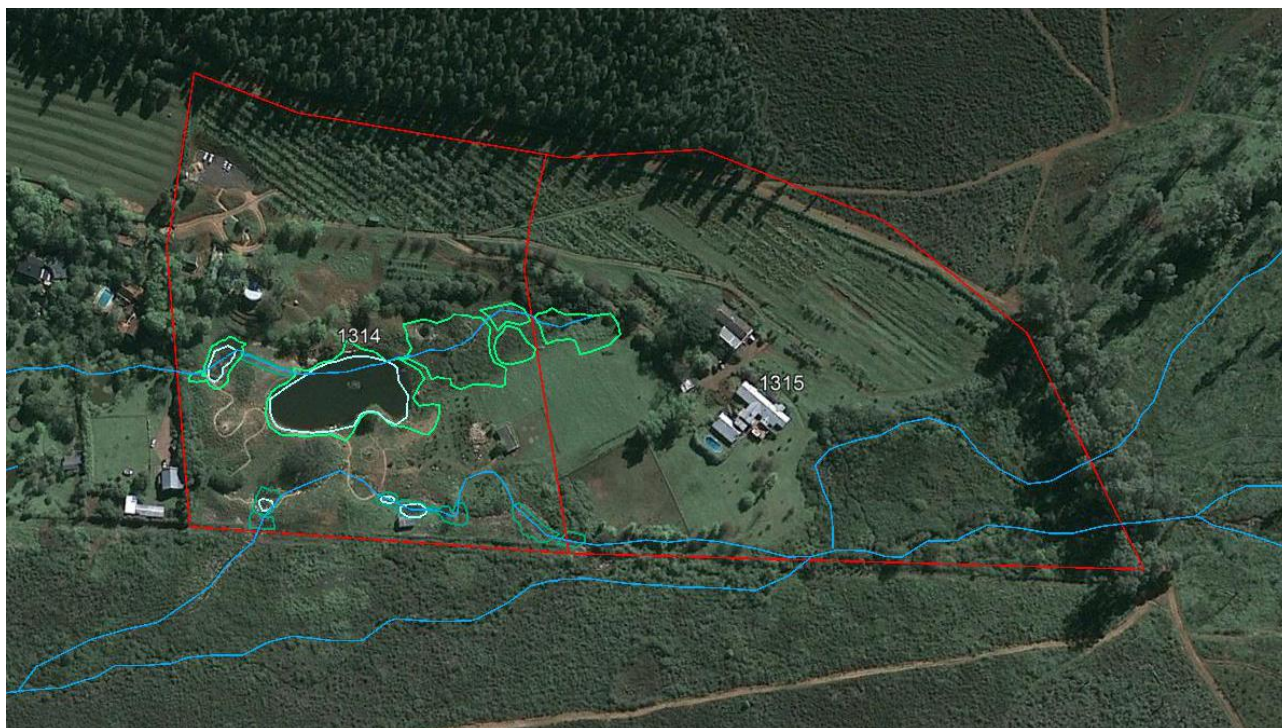
Figure 15. Google Earth image of the site with the present day delineated aquatic features, taken in September 2009

Figure 15 shows the existing larger dam as well as the small pond near the western border of the site had been constructed but not the series of detention ponds to reduce the erosion potential of the Paradyskloof River. Clearing of alien vegetation such as Port Jackson willows *Acacia saligna* and Paterson's curse *Echium plantagineum* and revegetating with indigenous vegetation had also not yet commenced. A pathway through Farm 1314 was already underway and although the date when the weir over the stream along the western border of the farm was constructed, it is highly likely to have been constructed by this date.

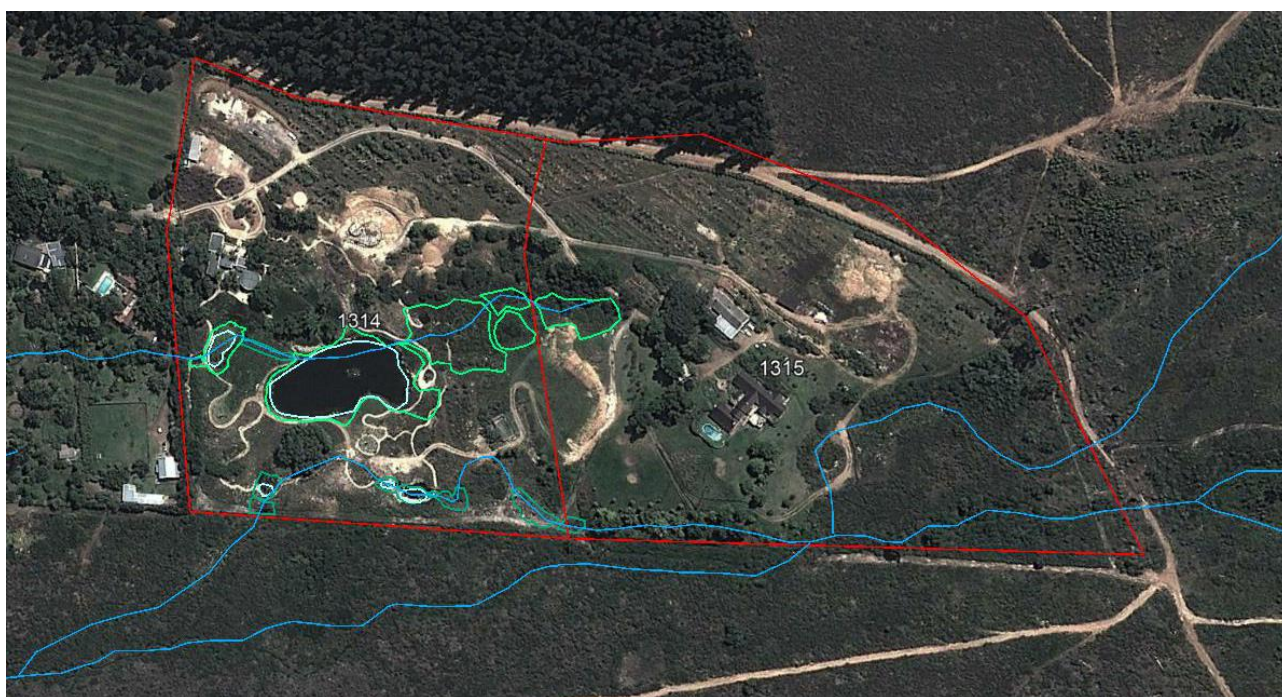
Figure 16. Google Earth image of the site with the present day delineated aquatic features, taken in November 2013

By 2014 (Figure 16), construction of the sculpture garden had commenced and establishment of the pathway was well underway. The small detention dams also appear to have been created during this period. Figure 17 shows the further creation of the pathway, revegetating of the area and clearing of alien vegetation. The large filled platform along the border between Farm 1314 and Farm 1315 was also being undertaken at this time.

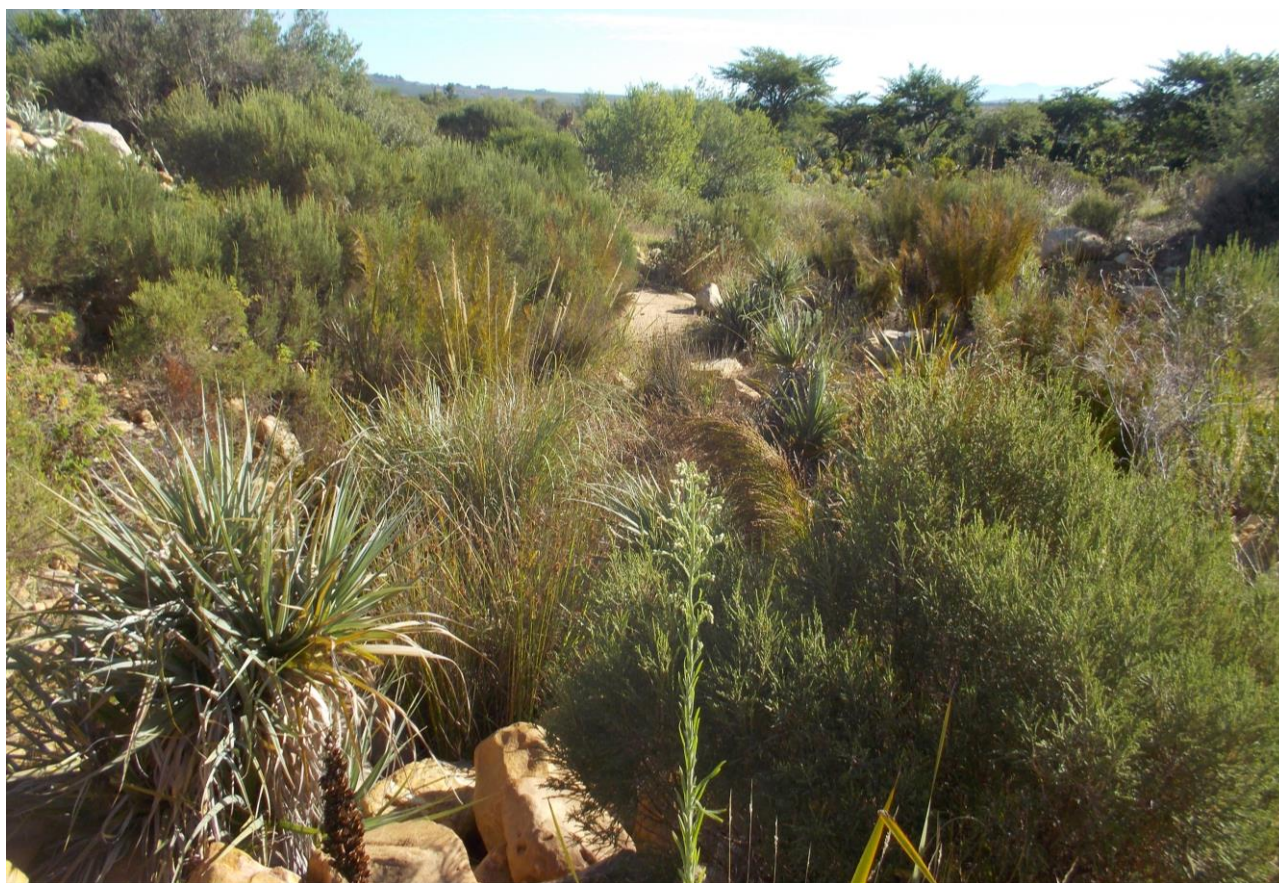
The Paradyskloof River is only still natural within its first kilometre within the Hottentots-Holland Mountain Catchment Area. Downstream of this it becomes increasingly modified. The upper reaches of the river are impounded by the dam within the site and then it flows through agricultural areas to its confluence with the Blaauwklippen River. Through most of this area, apart from the flow modification from abstraction and storage, the river channel has been modified through removal of the riparian habitat and modifications to the channel. Within the site the river has been modified by past activities but has also been rehabilitated.

Figure 18. The rehabilitated Paradyskloof River within the site

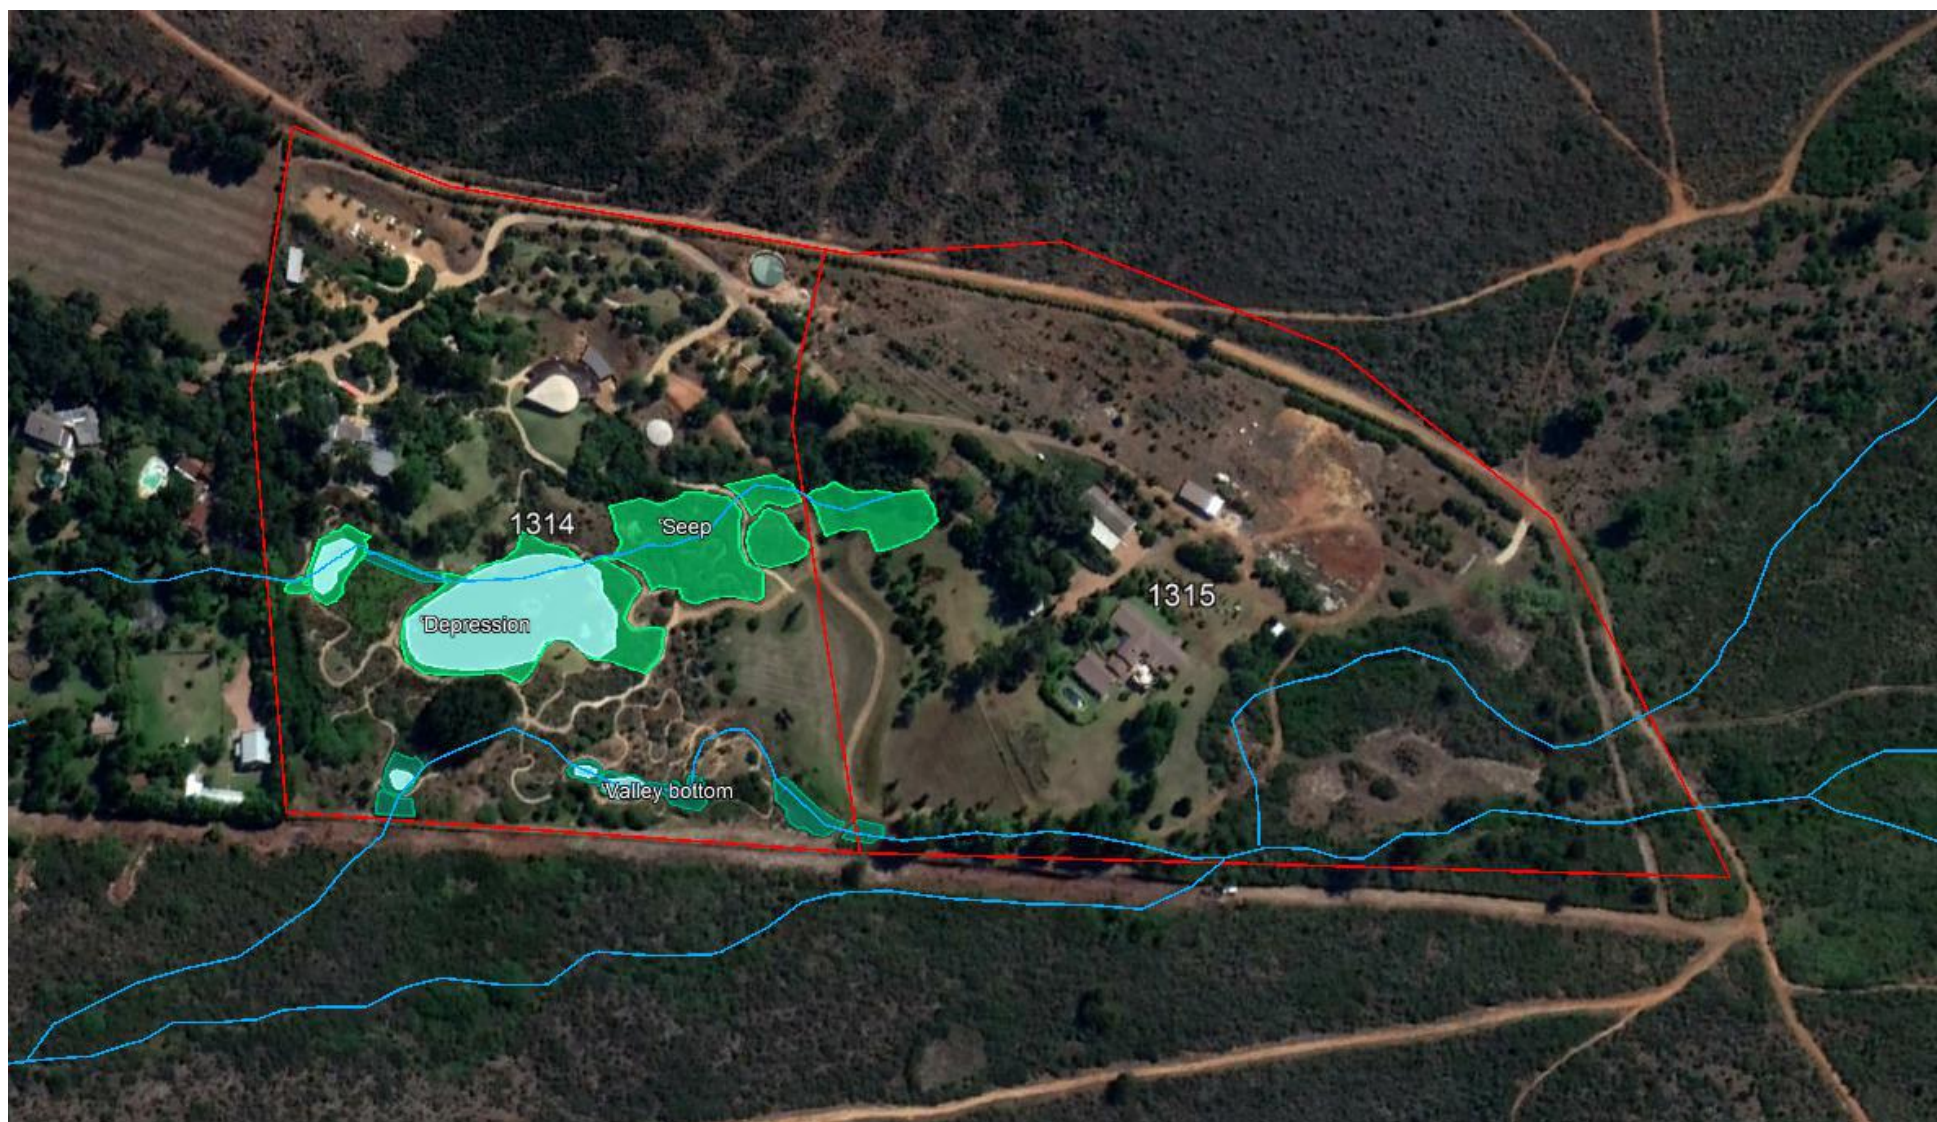
Figure 19. Google Earth image with the mapped areas within the site where the activities have been undertaken

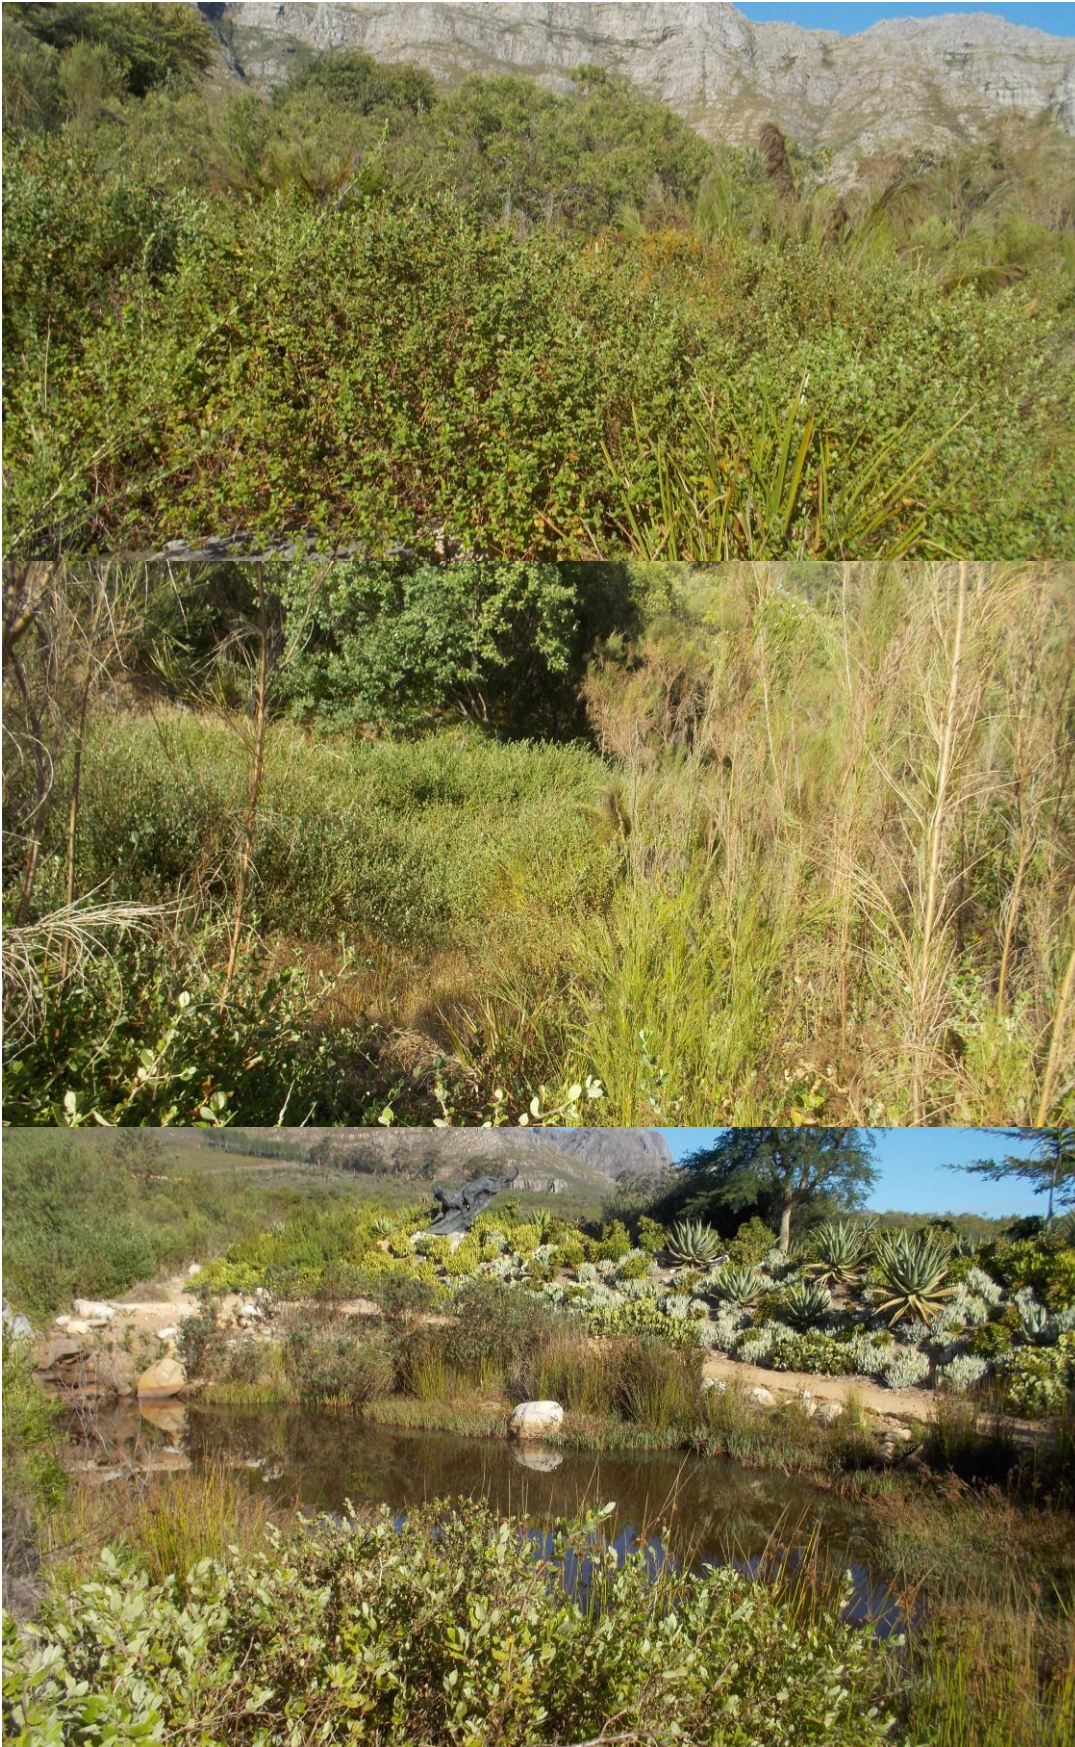
There are three types of wetlands within the site: a hillslope seep wetland associated with the smaller tributary of the Paradyskloof River; some depression wetlands that have been artificially created and the valley bottom wetland associated with the Paradyskloof River channel (Figure 15). Although the depression wetlands are artificial wetlands they have been created and vegetated to form natural wetlands that provide valued goods and services and for this reason have been included in this assessment.

Figure 20. View of the hillslope seep (top), valley bottom wetland (middle) and depression wetlands (bottom)

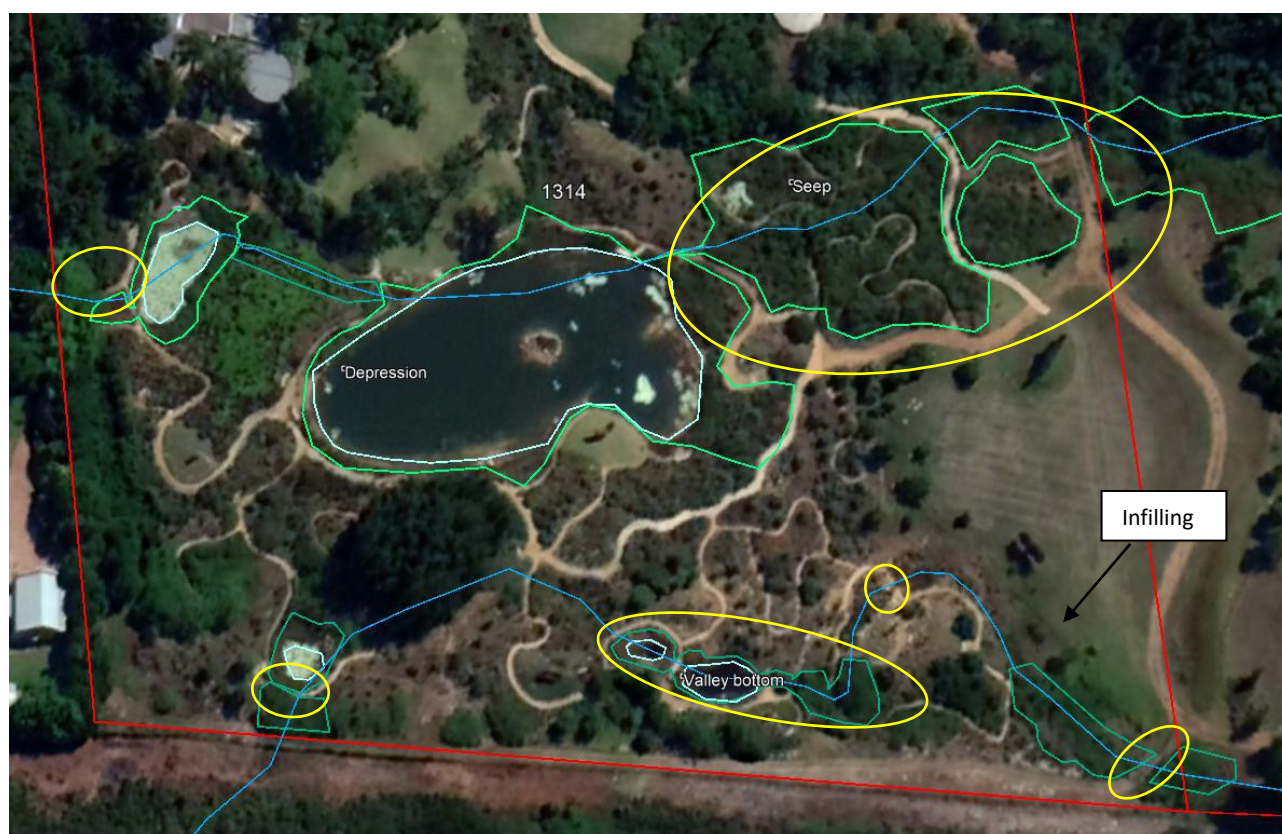
The walkway through the created garden has needed to cross the delineated watercourses and wetland areas in a number of places (Figure 22). These crossings are largely comprised of steppingstones placed within the watercourses (Figure 23). The pathway itself just comprises of a narrow sand / gravel track with minimal intrusion into the aquatic features. Adjacent to the pathway, the aquatic habitats have been rehabilitated and vegetated with suitable local indigenous wetland vegetation. Where necessary, the aquatic habitats have been reshaped and alien vegetation has been removed to enhance the habitats.

Figure 22. Google Earth image showing the mapped aquatic features with the yellow ovals indicating where the walkway has been constructed within these delineated aquatic features

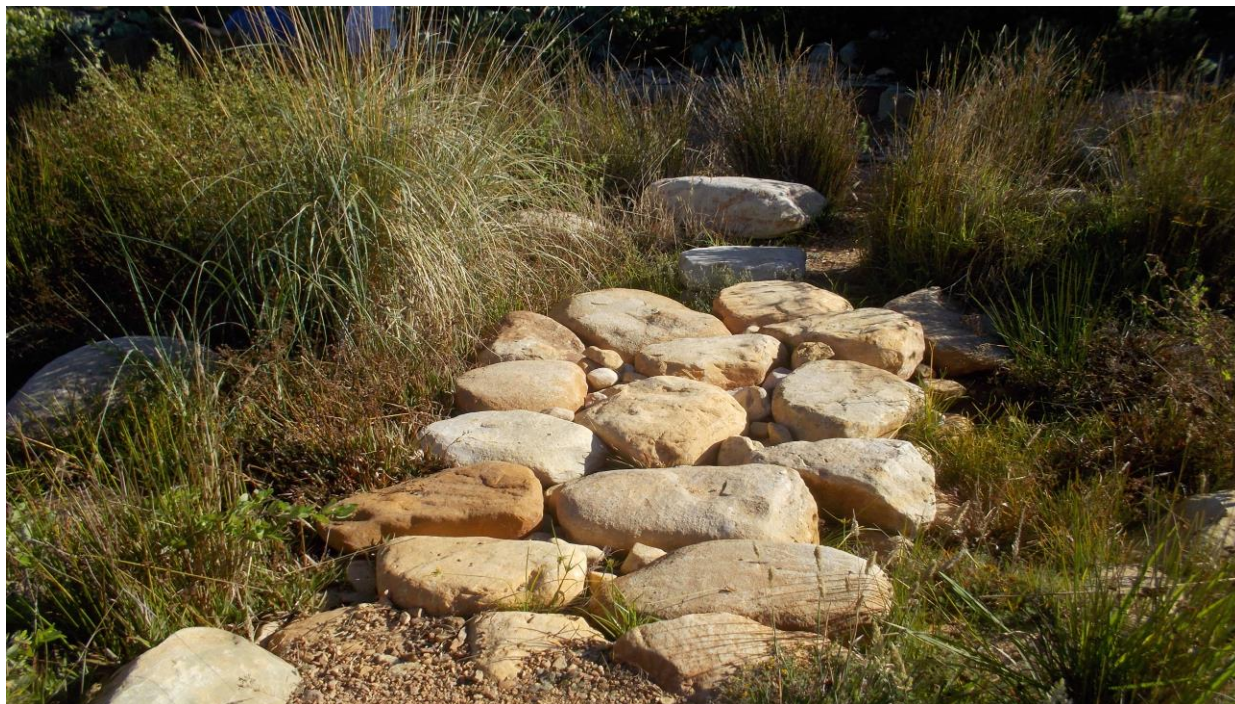
Figure 23. View of the typical watercourse crossings at the site

Potential impacts of the activities undertaken are some aquatic habitat modification; and a localised impedance of flow within the watercourses at the crossings. Given that considerable effort has been undertaken to enhance and improve the aquatic habitats within the garden the impact of the created walkway has been limited and in general has resulted in the improvement of the ecological integrity of the aquatic features that had been modified by past agricultural activities within the site and were invaded with alien vegetation such as Paterson's curse (Figure 25).

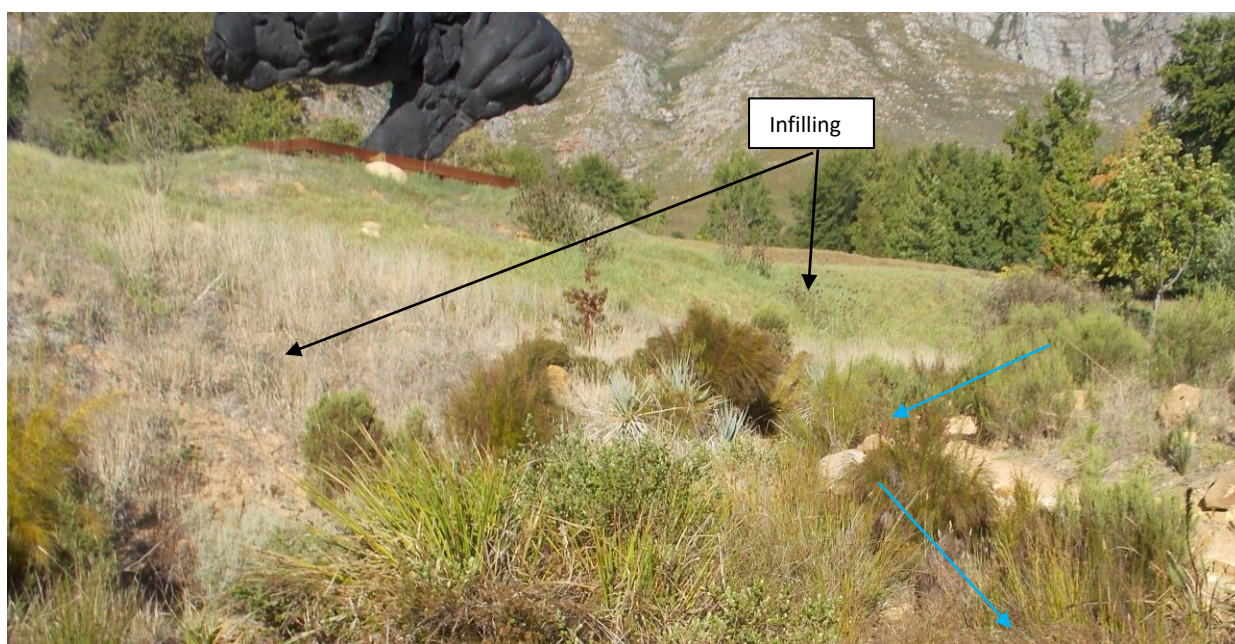
Infilling of the area that has primarily taken place associated with the creation of the sculpture garden comprises of a platform along the eastern boundary of Farm 1314 (Figure 22 and Figure 24). A portion of the infilling is directly adjacent to the watercourse but outside of the active channel of the watercourse.

Figure 24. View of the infilling along the north-eastern bank of the watercourse within the site

The only activity within or adjacent to the aquatic features that requires some rehabilitation is the infilled area adjacent to the Paradyskloof Stream. While it is not deemed necessary to remove the infilled material, it is recommended that the invasive kikuyu *Pennisetum clandestinum* grass cover on the embankment be removed and that the embankment be revegetated with indigenous vegetation. In particular, the banks of the stream where there is a bend in the watercourse should be vegetated and if necessary stabilised with larger boulders to prevent undercutting of the embankment by the stream.

While it is not deemed necessary to remove the infilled material, it is recommended that the invasive kikuyu *Pennisetum clandestinum* grass cover on the embankment be removed and that the embankment be revegetated with indigenous vegetation. In particular, the banks of the stream where there is a bend in the watercourse should be vegetated and if necessary stabilised with larger boulders to prevent undercutting of the embankment by the stream.

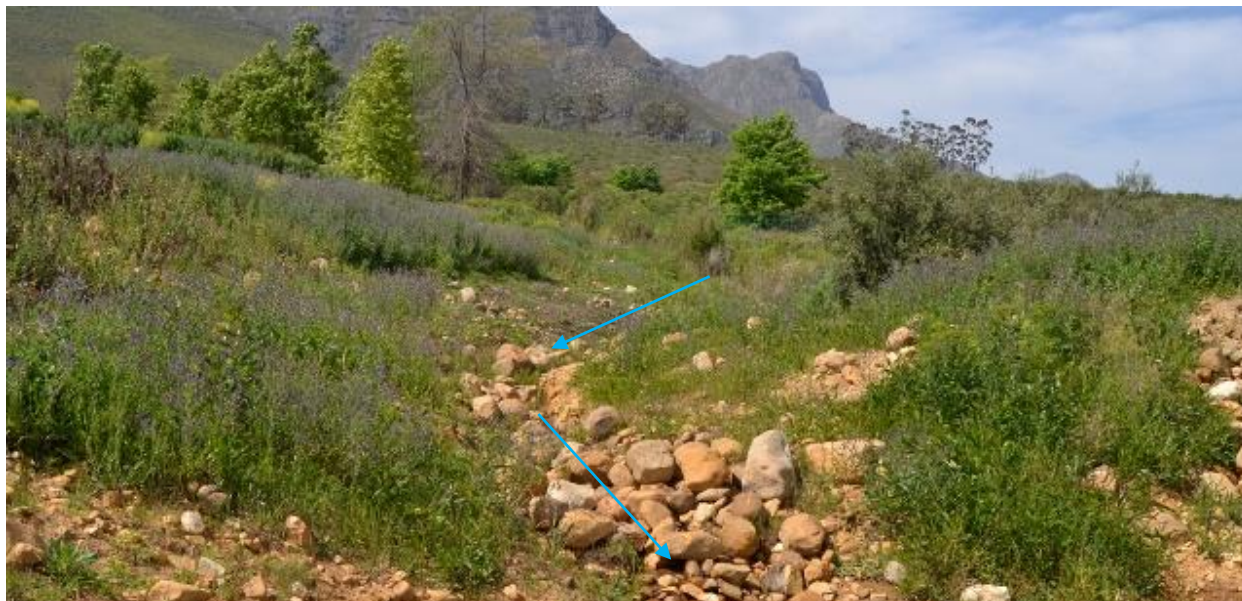
Figure 25. View of the Paradyskloof River at the infilled embankment shown in Figure 25, prior to rehabilitation

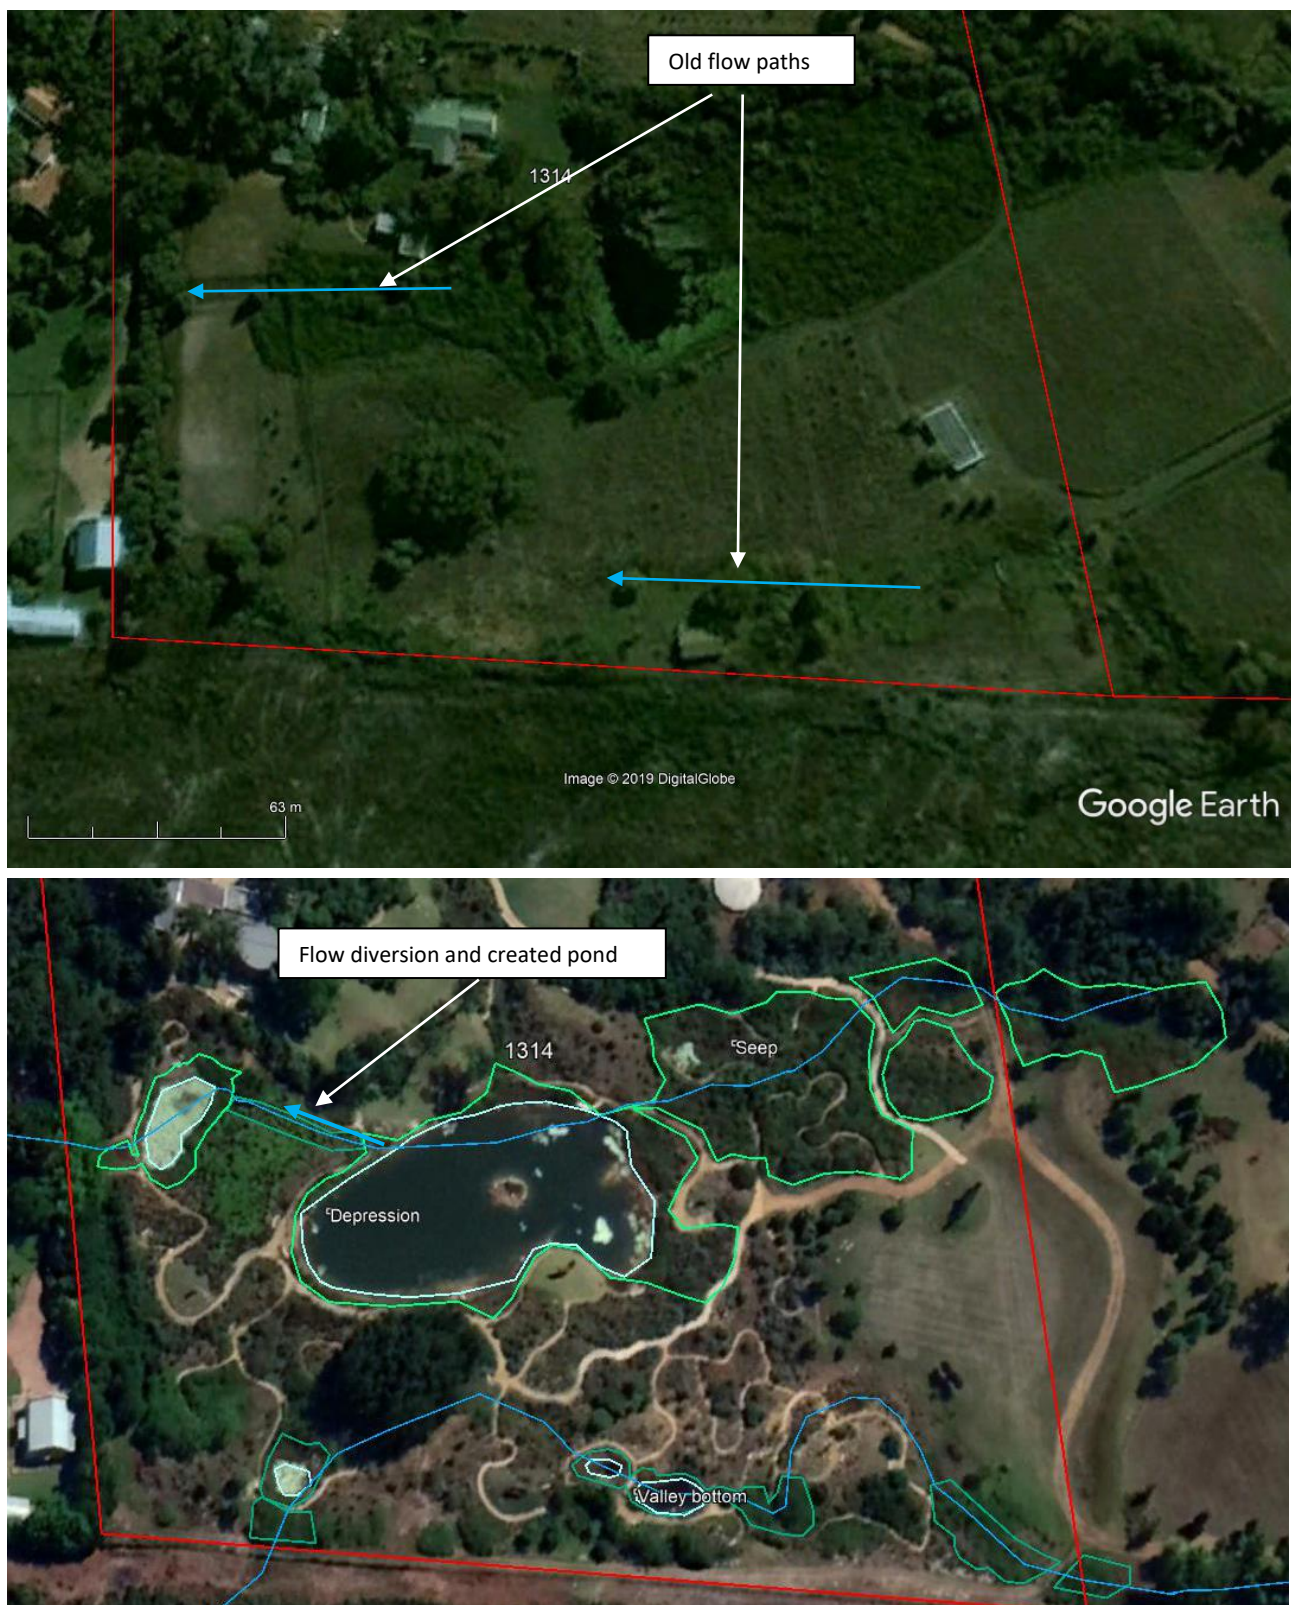
Only one flow diversion appears to have been undertaken as part of the garden establishment, that is the diversion of some flow from the large dam within the site to maintain the created pond near the western

boundary of the site. The series of ponds created along the southern boundary of the site is along one of the channels of the Paradyskloof River (Figure 26).

Figure 26. Comparison of the Google Earth image for 2005 with the most recent image (2019) with the mapped aquatic features. The flow diversion is indicated by the blue arrow.

The impact on downstream flow would thus not be such much an impact on the downstream volume of water but rather an impact on the flow pattern. As the water in the dam is not significantly utilised, the dam usually spills and it is the low flows that are impounded by the dam when there are insufficient flows for the dam to spill and there is still evaporative water losses from the dam. This impact on flow would have also occurred for the previously existing dam but would have increased as a result of the larger constructed dam. Given the degraded condition of the watercourse downstream of the site, and the fact that the stream along its length appears to have a baseflow contribution from groundwater that sustains the aquatic ecosystem during the dry summer period, the impact of the dam on the downstream flow and aquatic ecosystem is considered of a low significance. A water use authorisation will need to be applied for with the Department of Water and Sanitation.

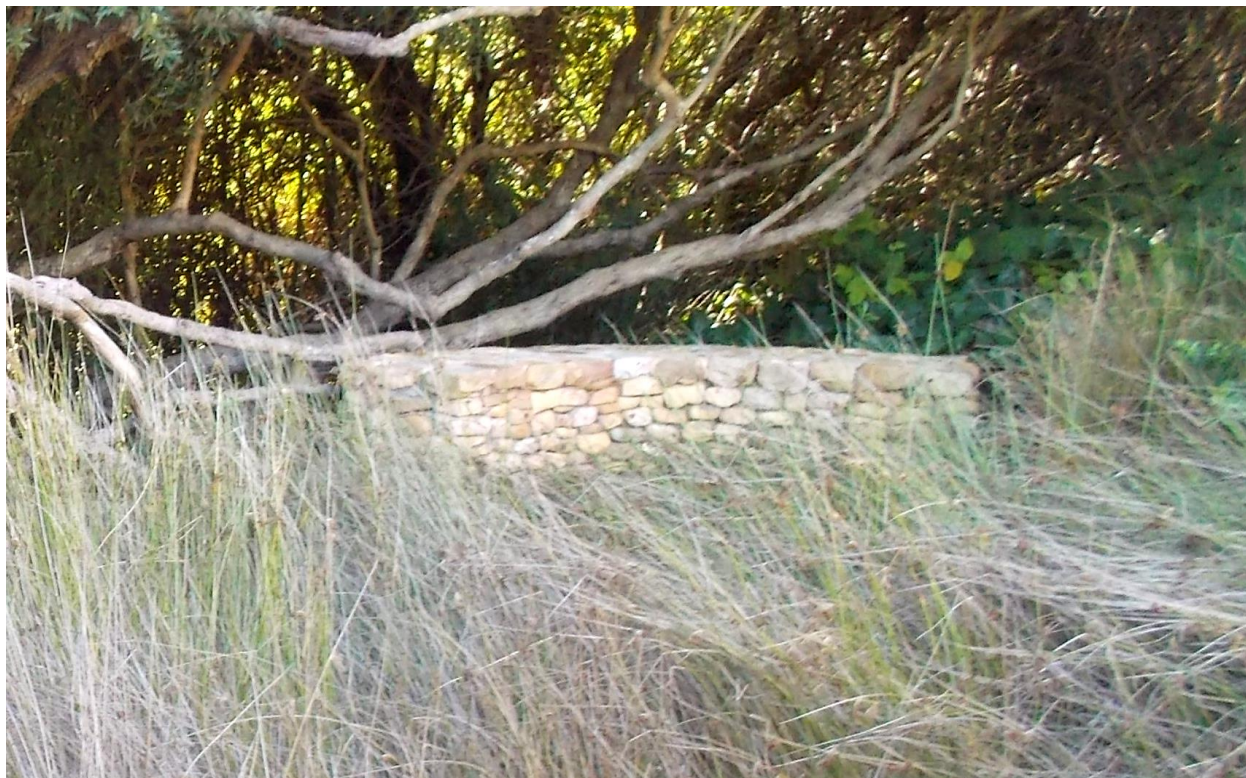
The only formalised crossing along the pathway is at the existing weir where a concrete walkway has been strengthened with a concrete structure of approximately 1.5 m wide and 2 m high (Figure 24). The structure acts also as an erosion mitigation as the watercourse drops downstream of the property and is likely to erode back into the site and the wetland area immediately upstream.

Figure 27. View of the constructed weir on the western boundary of the site

Significance of impact: Insignificant with the potential for a positive impact. There was an existing structure at the site of the weir that was degraded and becoming undercut but the eroding river channel downstream. The construction of the weir has addressed erosion taking place within the stream. The structure does not appear to significantly impede flow in the watercourse, except to facilitate the creation of the depression wetland habitat upstream. The created pond has been shaped and vegetated such that new wetland habitat has been created with an associated positive impact. No rehabilitation measures are deemed necessary for this activity.
