NOTIFICATION OF INTENT TO DEVELOP

**SECTION 24G RETROSPECTIVE ENVIRONMENTAL AUTHORISATION APPLICATION FOR
THE DEVELOPMENT OF A WEIR, BERMS, A WALKWAY, AND DIVERSION OF A
WATERCOURSE INTO A DAM ON MULBERRY FARM (FARM NO. 1314), STELLENBOSCH
RD, WESTERN CAPE PROVINCE**

**Supporting document to the Notification of Intent to Develop submitted to
Heritage Western Cape**

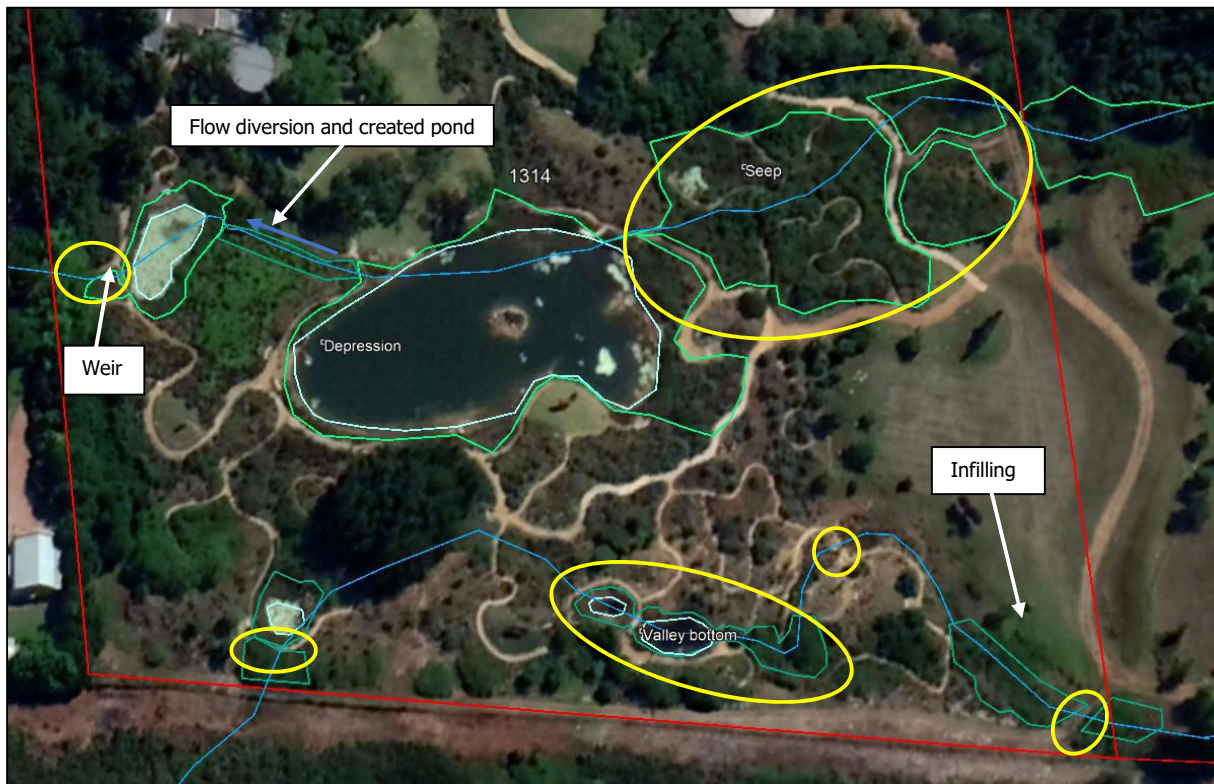
Figure 4. Activities applied for through the NEMA Section 24G application process, overlain on a recent Google Earth image. Yellow ovals: where the walkway has been constructed within the delineated aquatic features (Source: Adapted from BlueScience, 2019)

| <p>Provide a <u>full</u> description of the nature and extent of the proposed development or activity including its potential impacts (eg: changes in land use, envisaged timeframes, provision of additional bulk services, excavations, landscaping, total floor area, height of development, etc. etc.): The Dylan Lewis Trust acquired Farm 1314, Stellenbosch Registration Division (RD) during 2008. Up to 2008, the property was used for agricultural purposes.</p> <p>The Dylan Lewis Sculpture Garden was created gradually over time, mostly between 2009 and 2017. According to the Dylan Lewis Sculpture Garden website, over 60 sculptures constituting a comprehensive record of Lewis's full artistic development thus far have been carefully placed in harmony with the landscape. Along four kilometres of footpaths, one is led on a journey through different 'rooms'. The garden focuses on indigenous species, particularly fynbos. A large selection of ericas, particularly unusual varieties such as Erica verticillata, extinct in the wild, was sourced from Kirstenbosch National Botanical Garden.</p> <p>The DEA&DP, Directorate: Environmental Law Enforcement, has issued the Dylan Lewis Trust with a Compliance Notice and a Pre-directive for works undertaken adjacent to the Paradyskloof Tributary. A Section 24G application for retrospective Environmental Authorisation will be lodged with the DEA&DP for the development of a weir, berms, a walkway, and diversion of a watercourse on the relevant property. The estimated total surface area of the activities is ~0.6ha.</p> <p>From Google Earth, it is evident that two buildings were removed/demolished on the southern and eastern boundaries of Farm No. 1314 between 2011 and 2014 (see Figure 2 in the Supporting Document). The applicant has confirmed that the building on the eastern boundary was a labourer's cottage erected by the previous owners in approximately 1980, at the time of the earthworks on the garden it was unoccupied and derelict. The labourer's structure had major structural issues and needed to be demolished for safety reasons. The building on the eastern boundary was a horse stables erected by the previous owners in approximately 1985. At the time of the earthworks on the garden it was derelict and used for storage.</p> <p>The only building that may be old enough to be considered of heritage value is a cottage next to the gate, which remains unaltered from its original format. The applicant has also confirmed that nothing of heritage or archaeological significance was disturbed or found on the site during establishment of the garden.</p> <p>Three alleged unlawful activities were assessed by BlueScience, as part of the Section 24G process, in terms of their potential freshwater impacts and were categorised as follows: 1) construction of a walkway and sculpture display within a watercourse with the associated infilling (i.e. berms); 2) diversion of the watercourse into a small dam and artificial pond; and 3) construction of a weir within a watercourse. The relevant impacts are summarised below. See Figure 4 in the Supporting Document for a site plan of the activities applied for as part of the Section 24G process.</p> | |

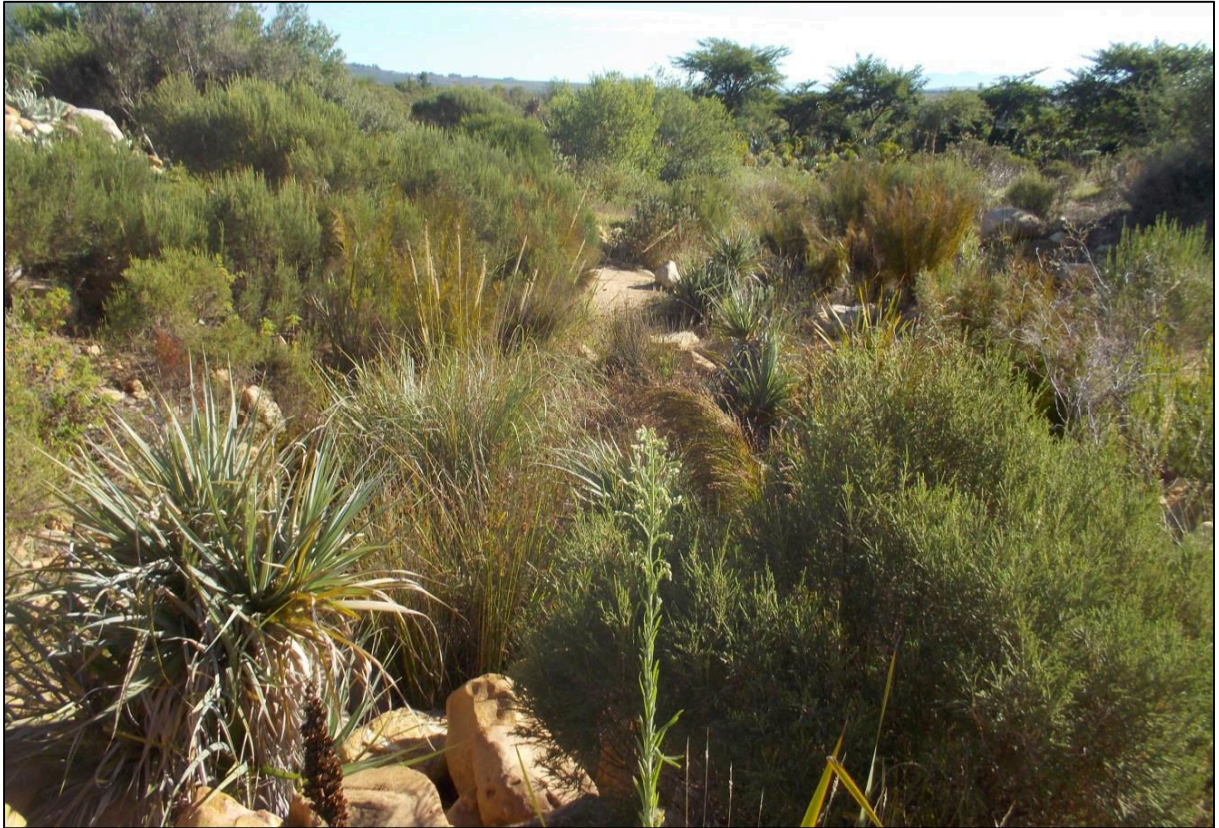
Photo 1: The rehabilitated Paradyskloof River on the site (Image source: BlueScience, 2019)

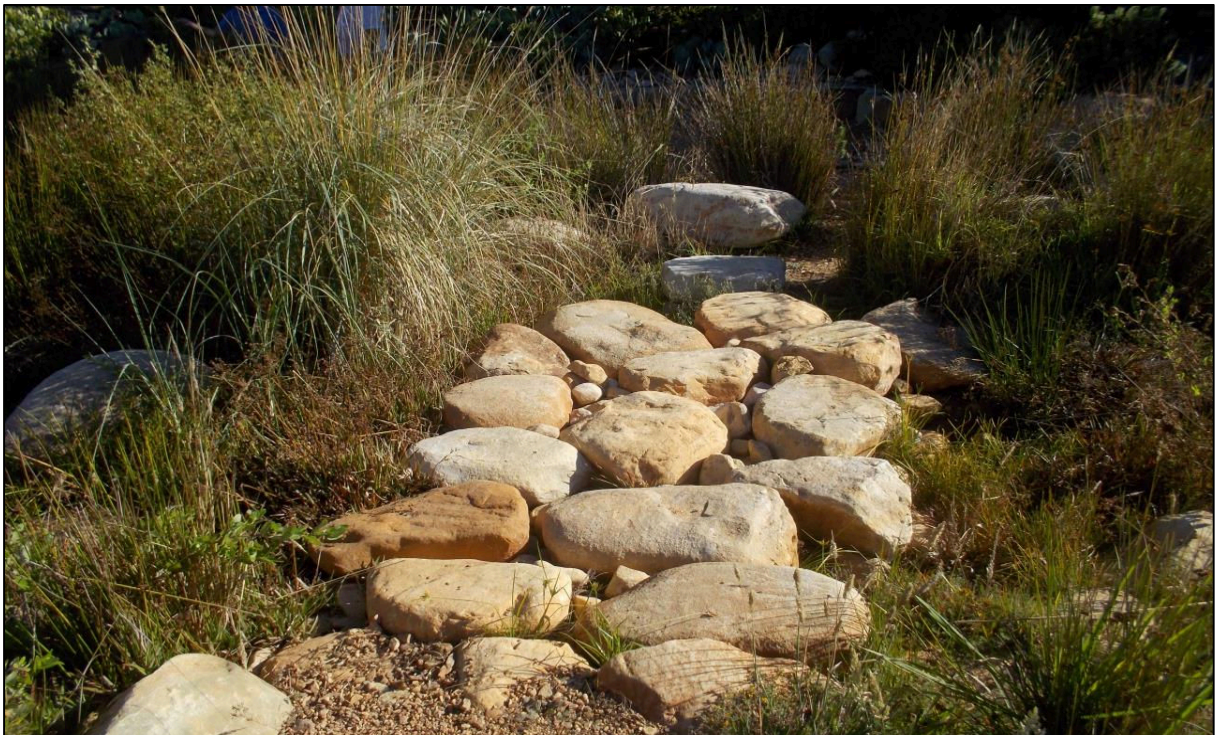
Photo 2: View of the typical watercourse crossings at the site (Image source: BlueScience, 2019).

Potential impacts of the activities undertaken are some aquatic habitat modification; and a localised impedance of flow within the watercourses at the crossings. Given that considerable effort has been undertaken to enhance and improve the aquatic habitats within the garden, the impact of the created walkway has been limited and in general has resulted in the improvement of the ecological integrity of the aquatic features that had been modified by past agricultural activities.

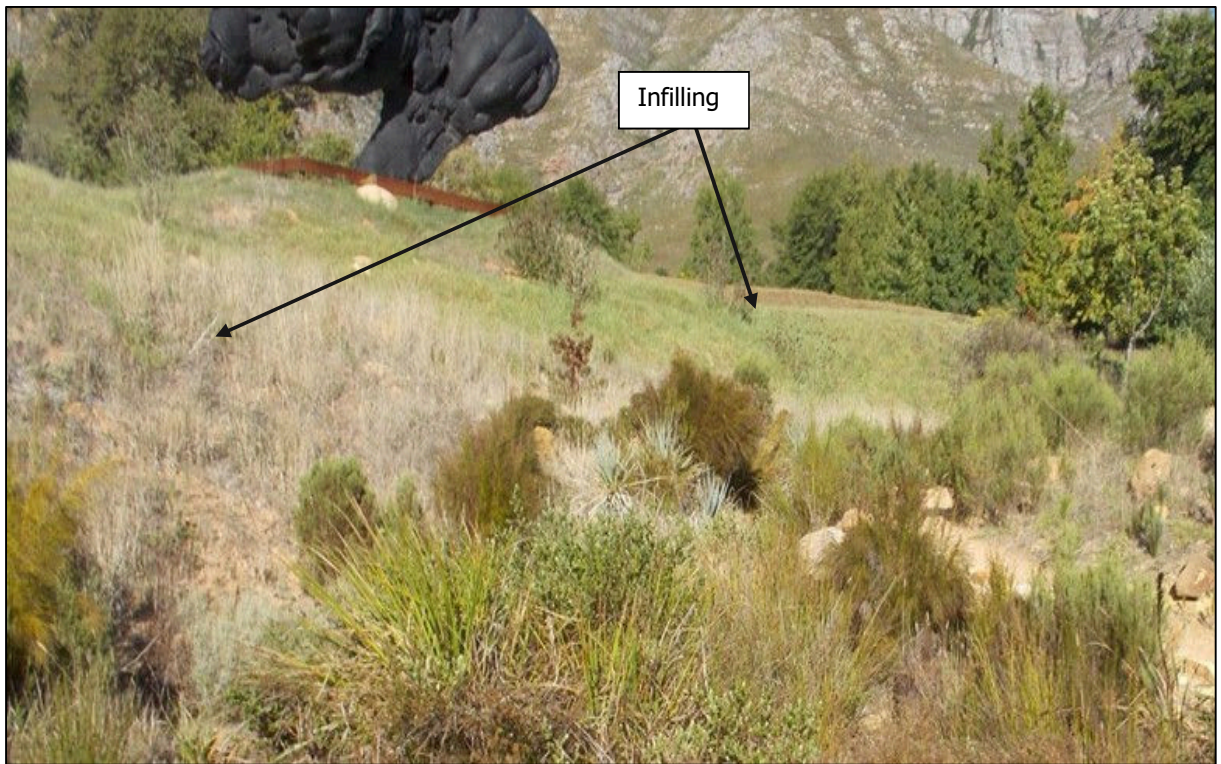
Photo 3: View of the infilling along the north-eastern bank of the watercourse within the site (Image source: BlueScience, 2019)

The only activity within or adjacent to the aquatic features that requires some rehabilitation is the infilled area adjacent to the Paradyskloof Stream. While it is not deemed necessary to remove the infilled material, it is recommended that the invasive kikuyu *Pennisetum clandestinum* grass cover on the embankment be removed and that the embankment be revegetated with indigenous vegetation. In particular, the banks of the stream where there is a bend in the watercourse should be vegetated and if necessary stabilised with larger boulders to prevent undercutting of the embankment by the stream.

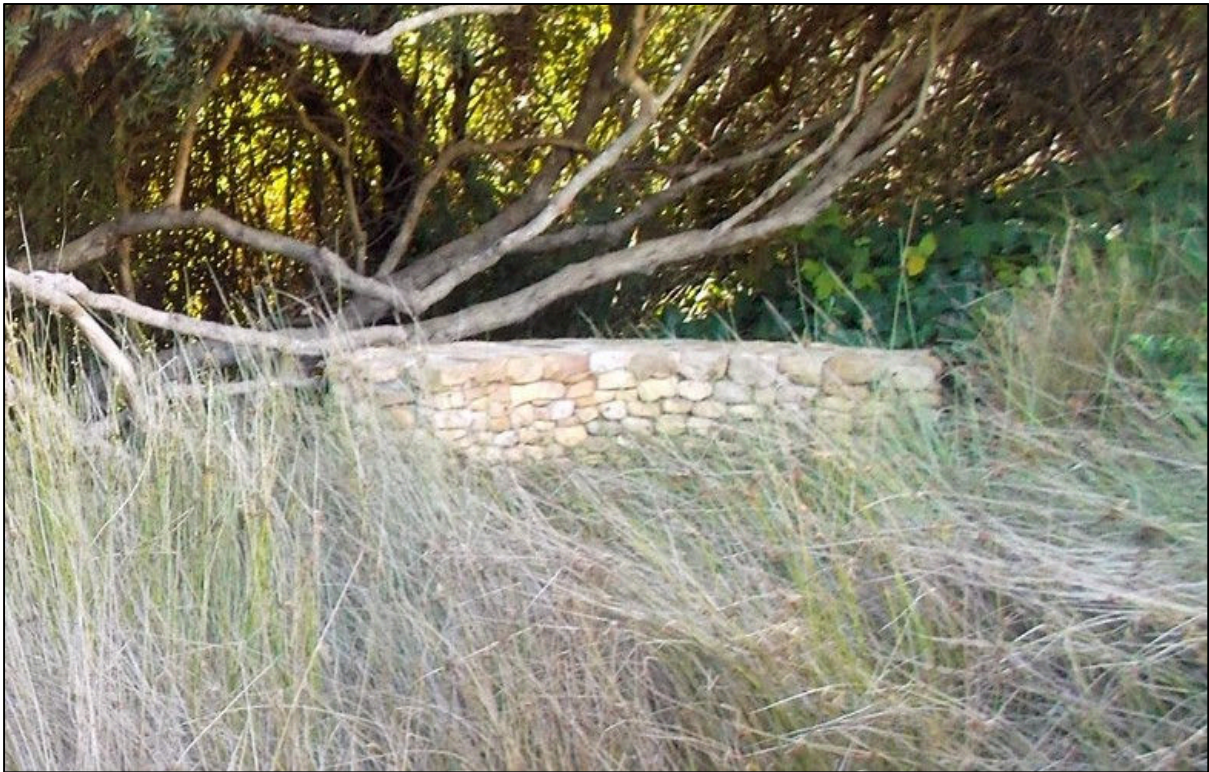
Photo 3: View of the constructed weir on the western boundary of the site (Image source: BlueScience, 2019)

The only formalised crossing along the pathway is at the existing weir where a concrete walkway has been strengthened with a concrete structure of approximately 1.5 m wide and 2 m high. The structure acts also as an erosion mitigation as the watercourse drops downstream of the property and is likely to erode back into the site and the wetland area immediately upstream.

The impact associated with this activity was found to be insignificant with the potential for a positive impact. There was an existing structure at the site of the weir that was degraded and becoming undercut but the eroding river channel downstream. The construction of the weir has addressed erosion taking place within the stream. The structure does not appear to significantly impede flow in the watercourse, except to facilitate the creation of the depression wetland habitat upstream. The created pond has been shaped and vegetated such that new wetland habitat has been created with an associated positive impact. No rehabilitation measures are deemed necessary for this activity.
