MARTIN & EAST (PTY) LIMITED CIVIL ENGINEERING AND SPECIALIST CONTRACTORS

6417/RM/30 Report

HAZARDOUS WASTE DISPOSAL REPORT

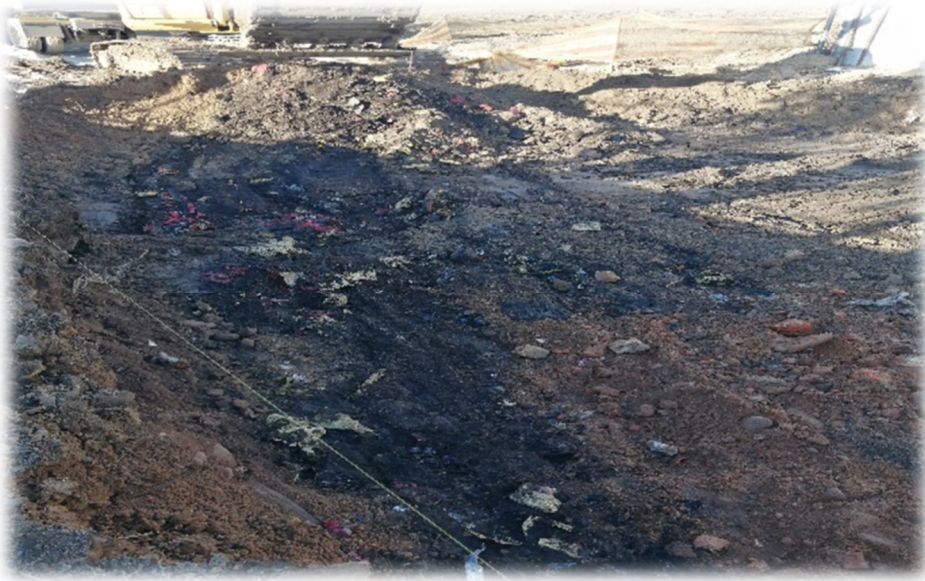
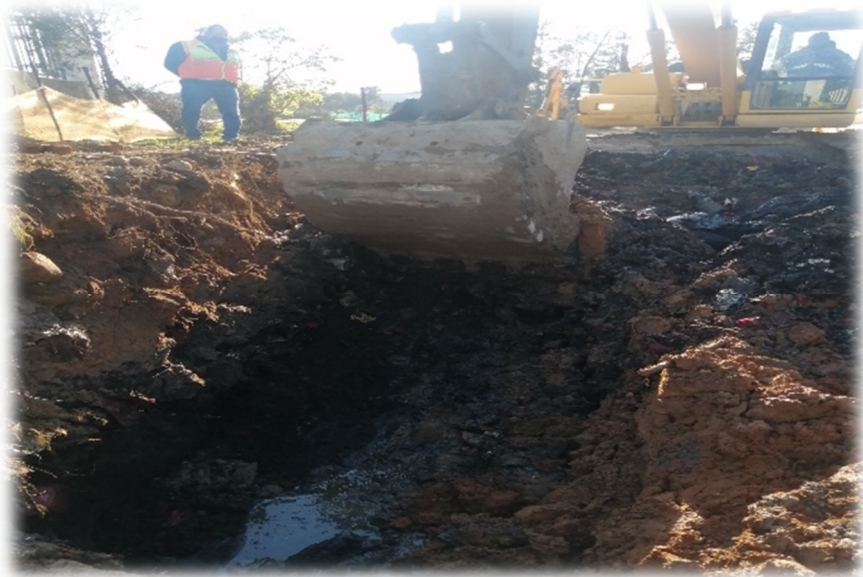
On 21 July 2020, Martin & East started with the box cutting operation along the private property, for it could not be done with the bulk due to the property that had to be fenced off. During this operation, the Contractor discovered waste material (red/yellow/green plastic bags and bottles) at roughly 1.5m- 2.0m below natural ground level. (see attached Annexure A for Photos)

Annexure C - Photos of discovered waste are listed below

The Engineers were notified immediately and the works were stopped and the material were seen as hazardous waste. The Engineers then instructed the Contractor to appoint an approved Waste Removal Service Provider to test the material and advise on the Method of Handling and Disposal.

The material was then tested and found to be a Class 3 Hazardous Material and had to be disposed at Visserhok Landfill Site and be disposed of by trench method. The material did not require special PPE during this operation, but the Contractor had to ensure that he removes all spilled material immediately if it fell in areas that were not affected during the spoiling process. The Contractor was allowed to load by means of Excavator onto WasteMart Trucks suited for the carting of the material.

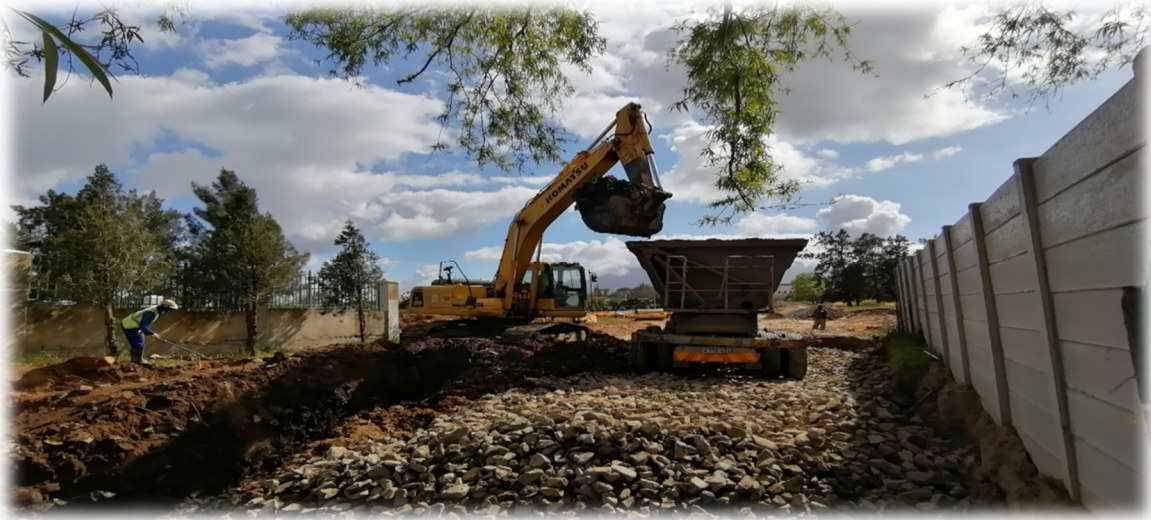
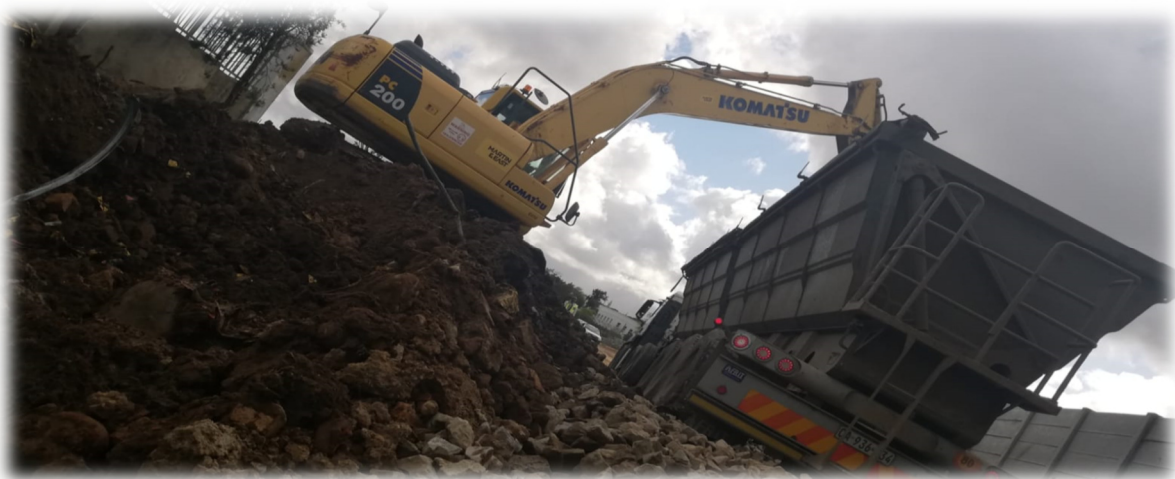
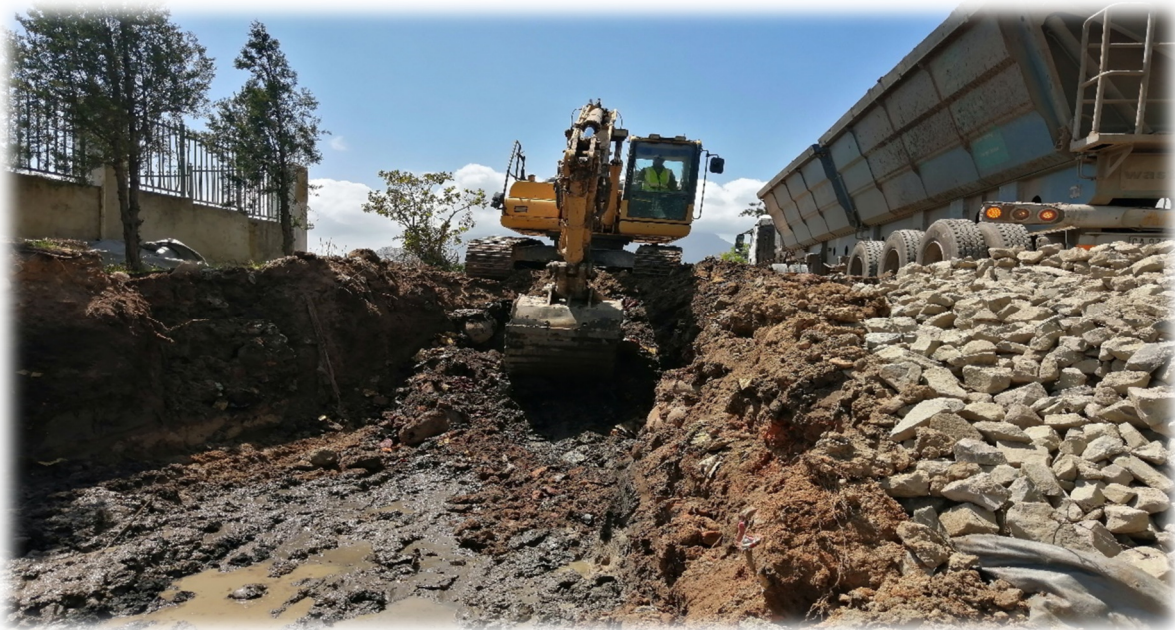
Annexure D – Removal Process involving Contractor and WasteMart

As the material was loaded and carted, the Engineer did a visual inspection and guided the Contractor in regards width and depth requirements to ensure that all material was removed. Once the go-ahead was given that Waste Material was removed successfully in an area, the Contractor did a Rockfill layer due to the unstable material.

A total of 322.78t of the hazardous waste was disposed at the Vissershok dumping site.
